Analysis Of Road Damage And Its Improvement On The South Ring Road And West Ring Road Of Jambi City

Tendy Laksana^{1*}, Melawaty Agustien², Edi Kadarsa²

¹Mahasiswa Program Pasca Sarjana, Fakultas Teknik, Universitas Sriwijaya, Jalan Srijaya Negara, Bukit Besar, Kecamatan Ilir Barat I, Kota Palembang, Sumatera Selatan, 30139, Indonesia

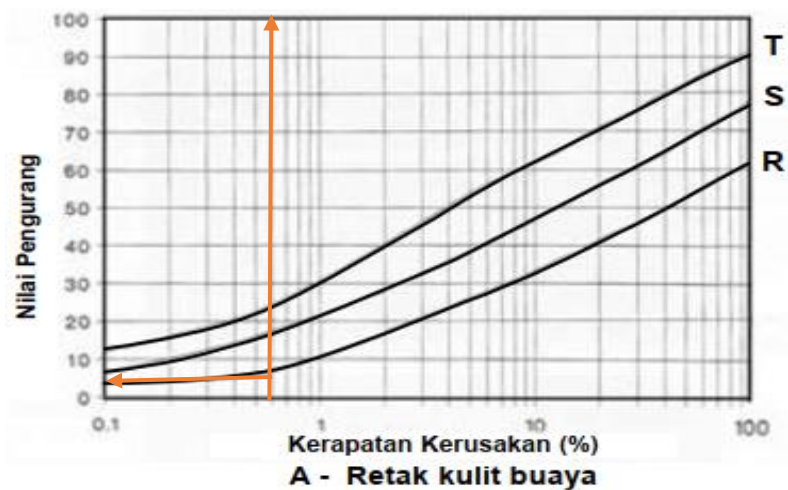
Figure 5. Graph of reduction value (NP) of asphalt pavement STA 01 +295

Density (D): 0.5%

STA: 01 + 245

Damage Level: R

Deductible Value (DV): 5%. This can be seen in the following graph figure 5 and figure 6.

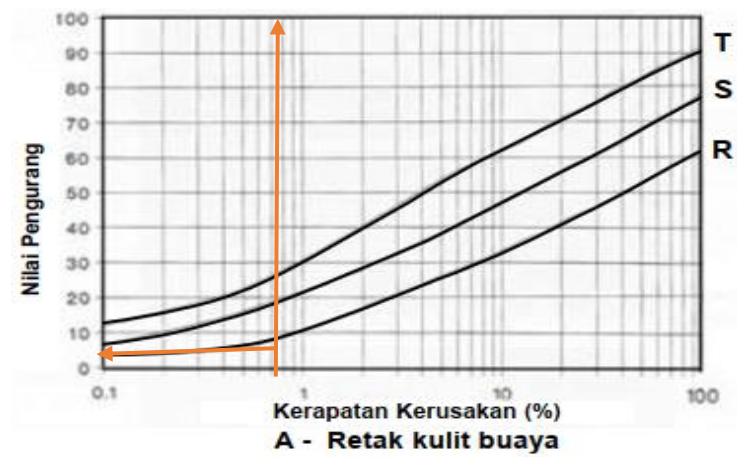
Figure 7. Graph of reduction value (NP) of asphalt pavement STA 01 + 125

STA : 01 + 125

Density (D) : 0.75%

Deterioration Level : R

Deductible Value (DV): 5%. This can be seen in the following graph figure.7 and figure. 8
